Manhole Inspection Summary

Manhole # S17QQ1026MH

Location Address: **YELLOWWOOD AVE**

Cross Street: **CORALBERRY CT**

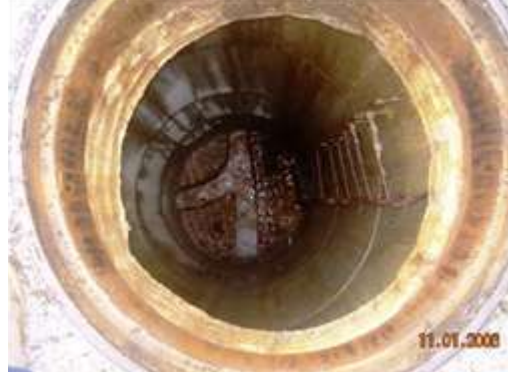
Top View

Corroded steps. Evidence of surcharge - Bench debris. Channel debris.

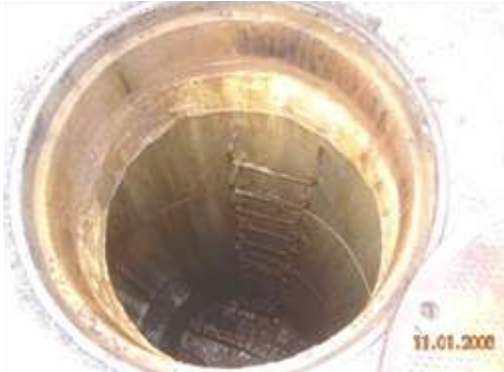
Defect

Frame leaks. Adjustment, Corbel, and Barrel infiltration.

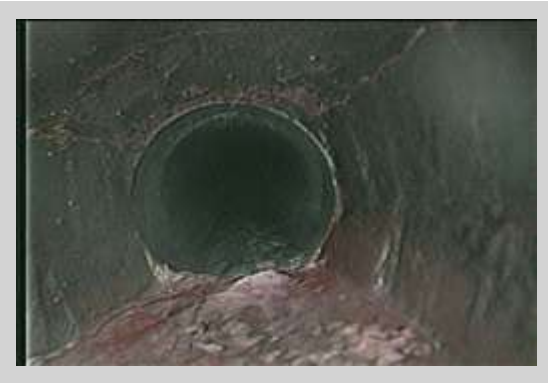
8 in. Circular Gravity Sewer Pipe Out @ 12 O'Clock

Deposits: ☐ None ☐ Mud ☐ Sludge ☒ **Debris** ☒ **Grease**

Silt Depth: **0.5** (in.) Deposits Extent: **Light**

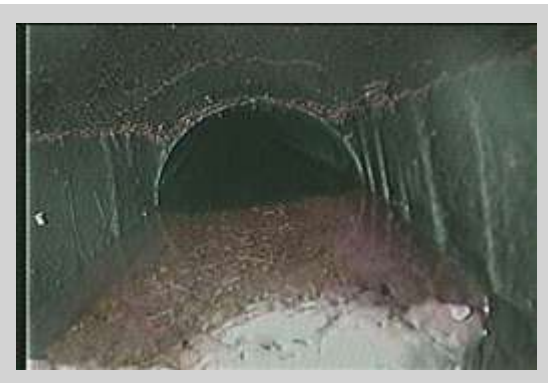
8 in. Circular Gravity Sewer Pipe In @ 6 O'Clock

Deposits: ☐ None ☒ **Mud** ☐ Sludge ☒ **Debris** ☐ **Grease**

Silt Depth: **1** (in.) Deposits Extent: **Light**

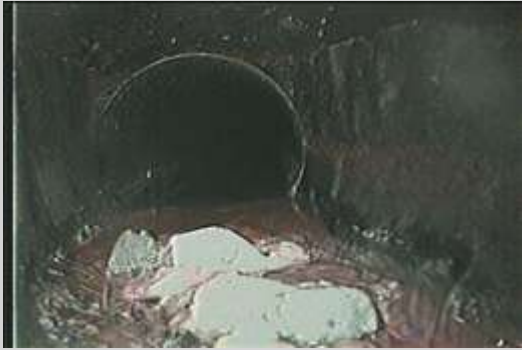
Pipe In @ 9 O'Clock

Deposits: ☐ None ☐ Mud ☐ Sludge ☒ **Debris** ☒ **Grease**

Silt Depth: **0.5** (in.) Deposits Extent: **Light**
